# Snohomish County Register of Historic Places Application

Property Name: Riverside Community Club

Property Address: 13725 Jordan Rd., Arlington, WA 98223

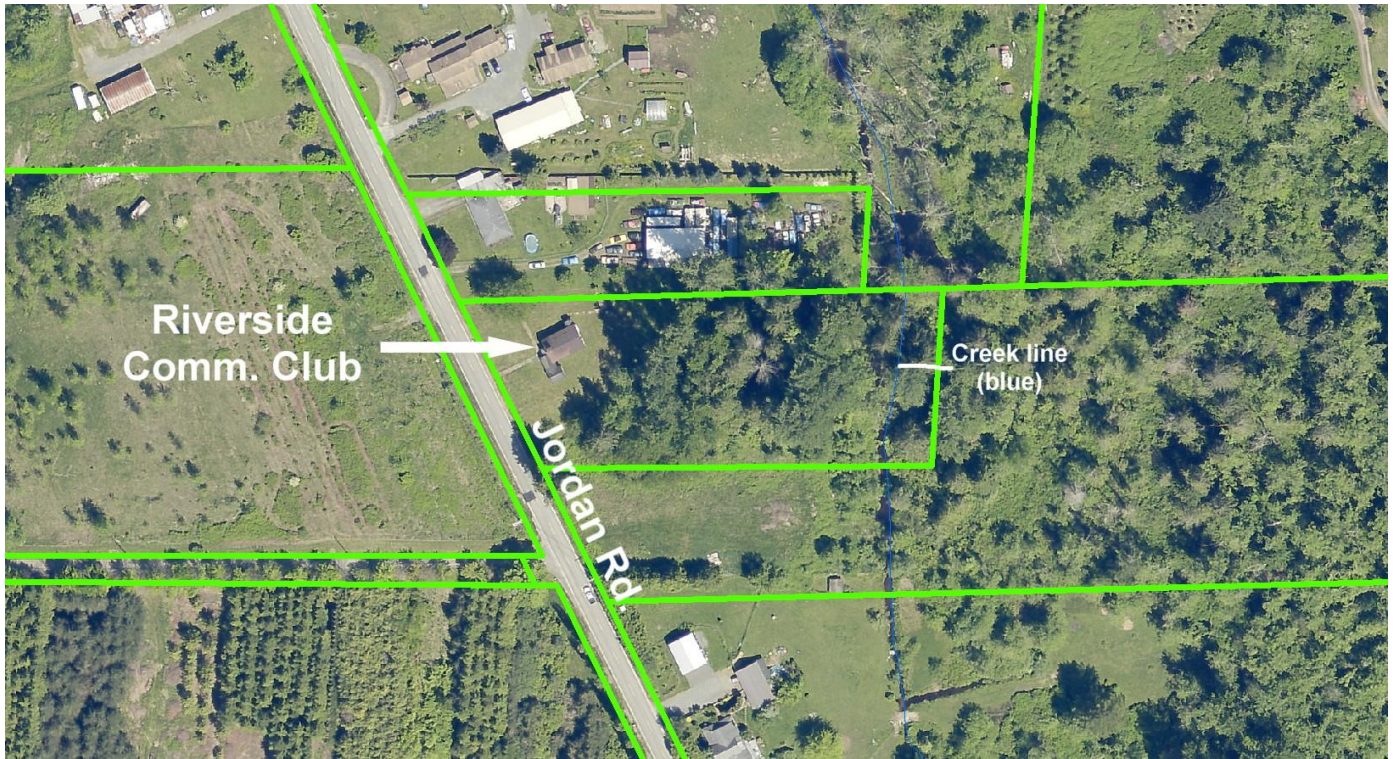
Riverside Community Club at 13725 Jordan Rd, Arlington, WA  
 Property lines shown in green. Creek line shown in blue, running N/S.

Parcel ID 30060200200700  
 Parcel size 1.88 acres.

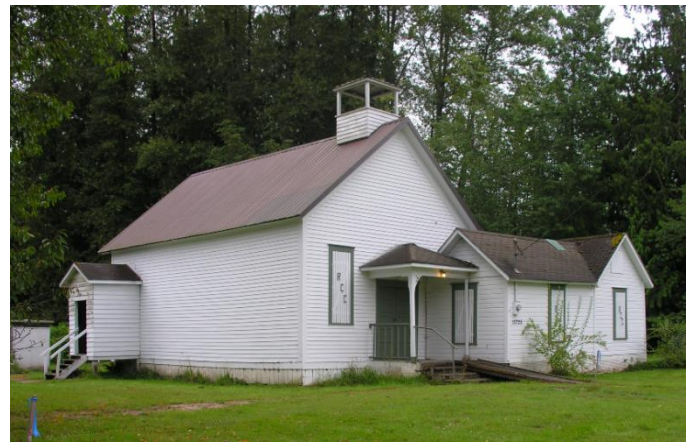
ca. 1960

Riverside School

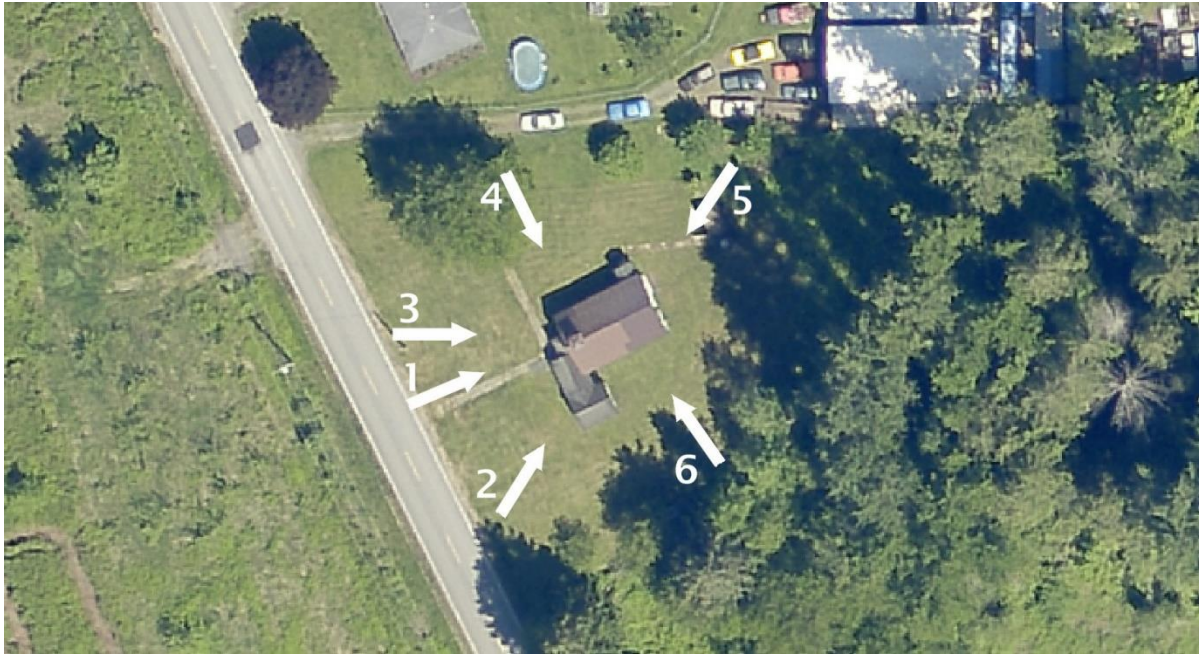
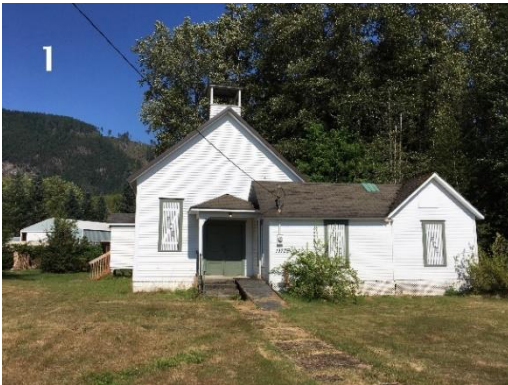
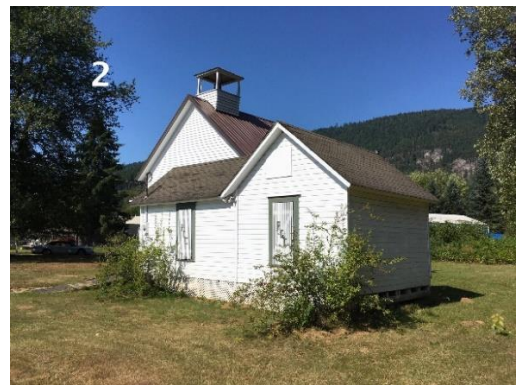
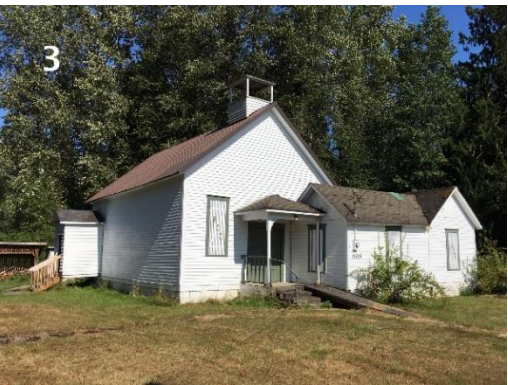
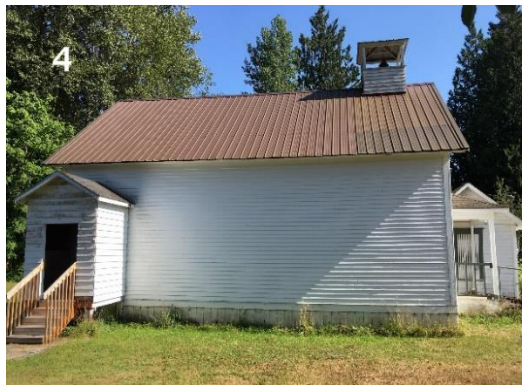
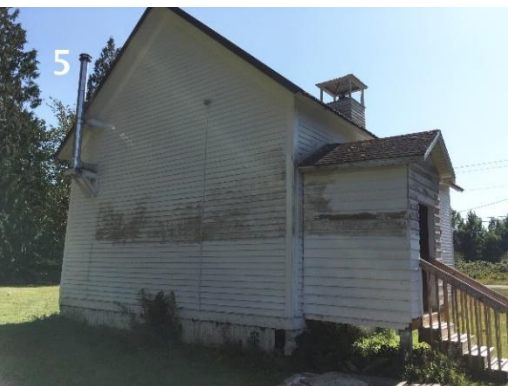
Interior Pictures:

As you enter the school building, the north (left) wall appears as though the windows are boarded over. In reality, there are no windows in that wall – there is a row of trestle tables/desks that fold down from the wall! Folded up, the entire floor area is clear.

The stove today is not the original, although in the original location. The flue now exits straight above the stove.

Wood floor is in remarkably good condition (although well-scuffed) as are the wood walls and ceiling. There is an access hole to the attic above and the bell tower.

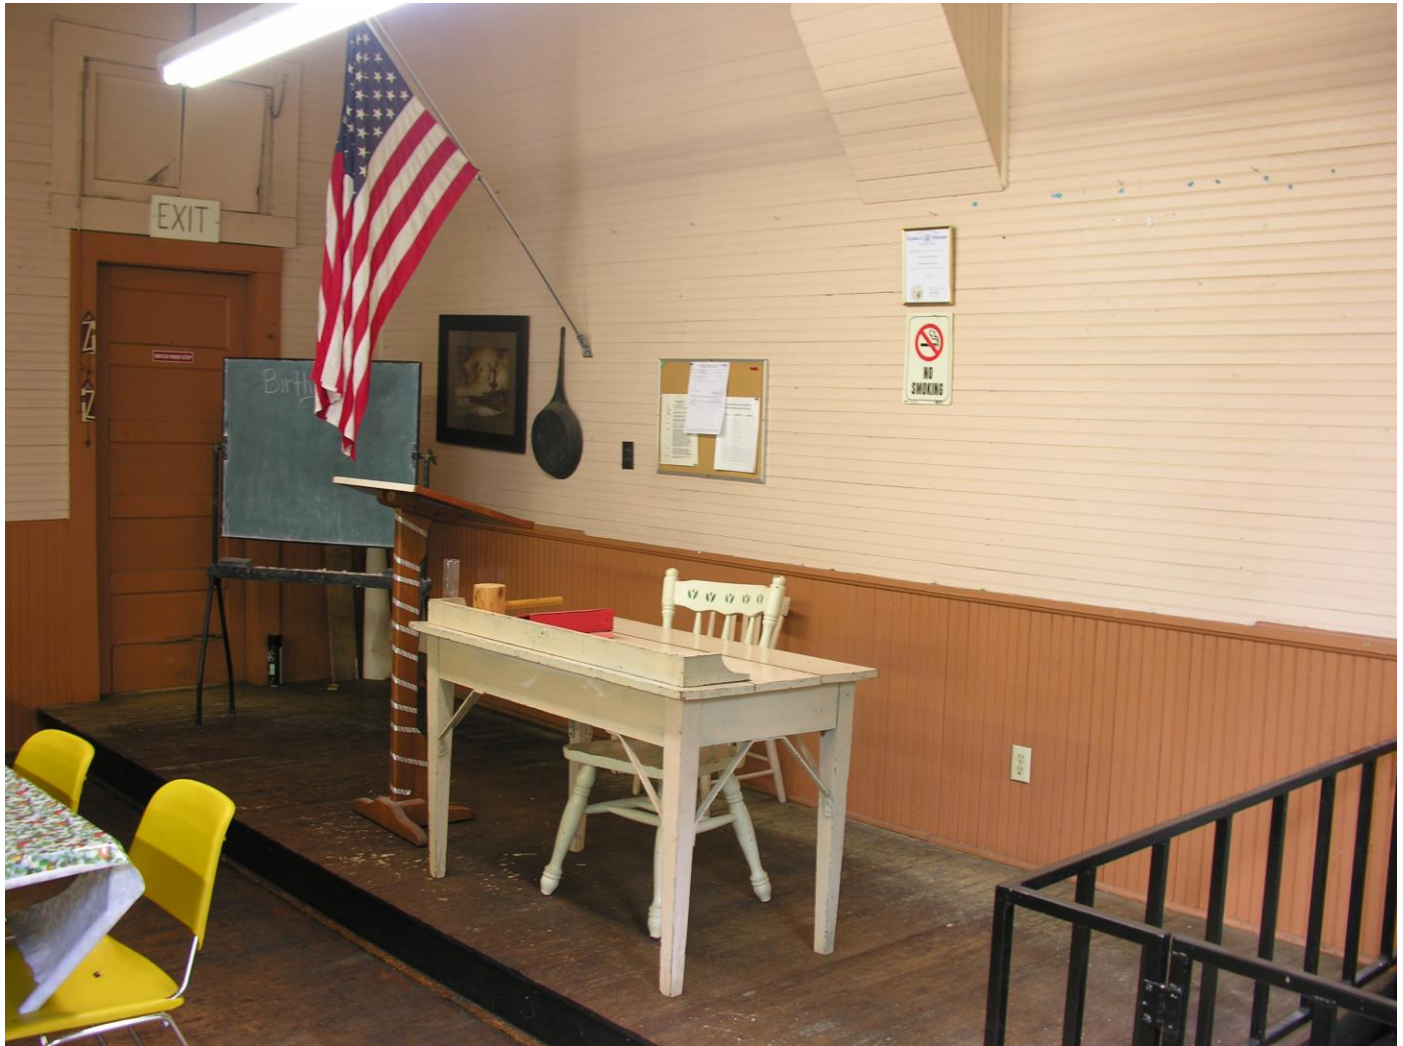
The east (far) end of the school building retains the original raised floor. The beveled enclosure at the top of the wall in the center is the old flue connection (the stove was in the southeast corner and the flue crossed to that point to enter the chimney).

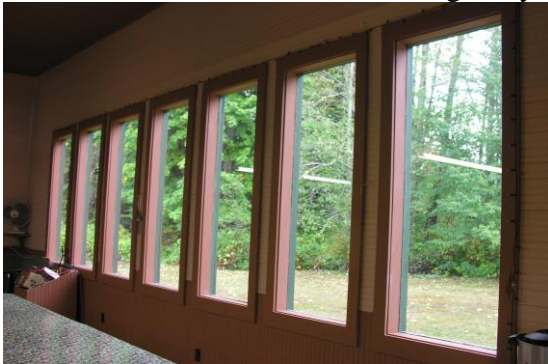
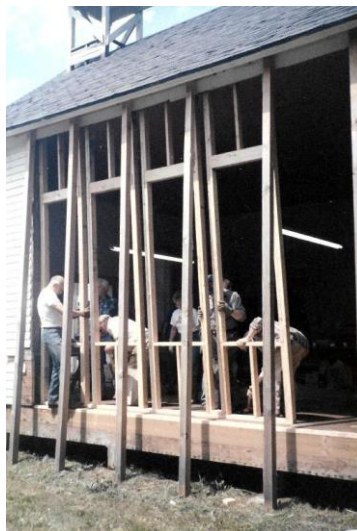
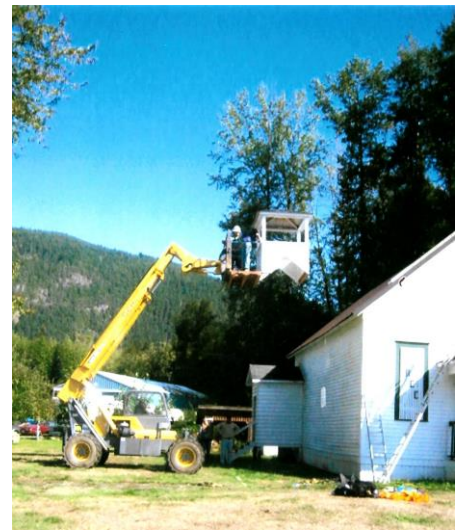
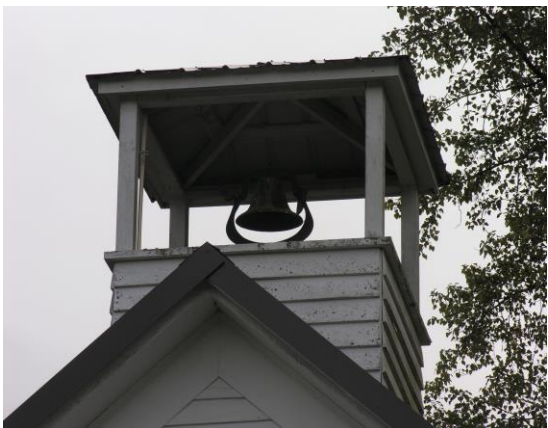
In addition, a row of seven high narrow windows, each with a corresponding short window above, were replaced in a 1980s renovation by seven windows of like height and width, but no windows above (See 1912 picture). It is not clear from earlier pictures if the high narrow windows were double-hung, but it is likely. These are on the south side of the school building, not visible from the road. The originals had been boarded up for years, for protection. The new windows are single-panel, not double-hung windows.

By the 1980s, the bell tower had deteriorated (the sustaining diagonal bracing is visible in the picture below, taken during the window remodeling). The bell tower was replaced when the entire building was re-roofed with metal in 2002. As originally, the bell can be rung from within the school, using a pull rope!

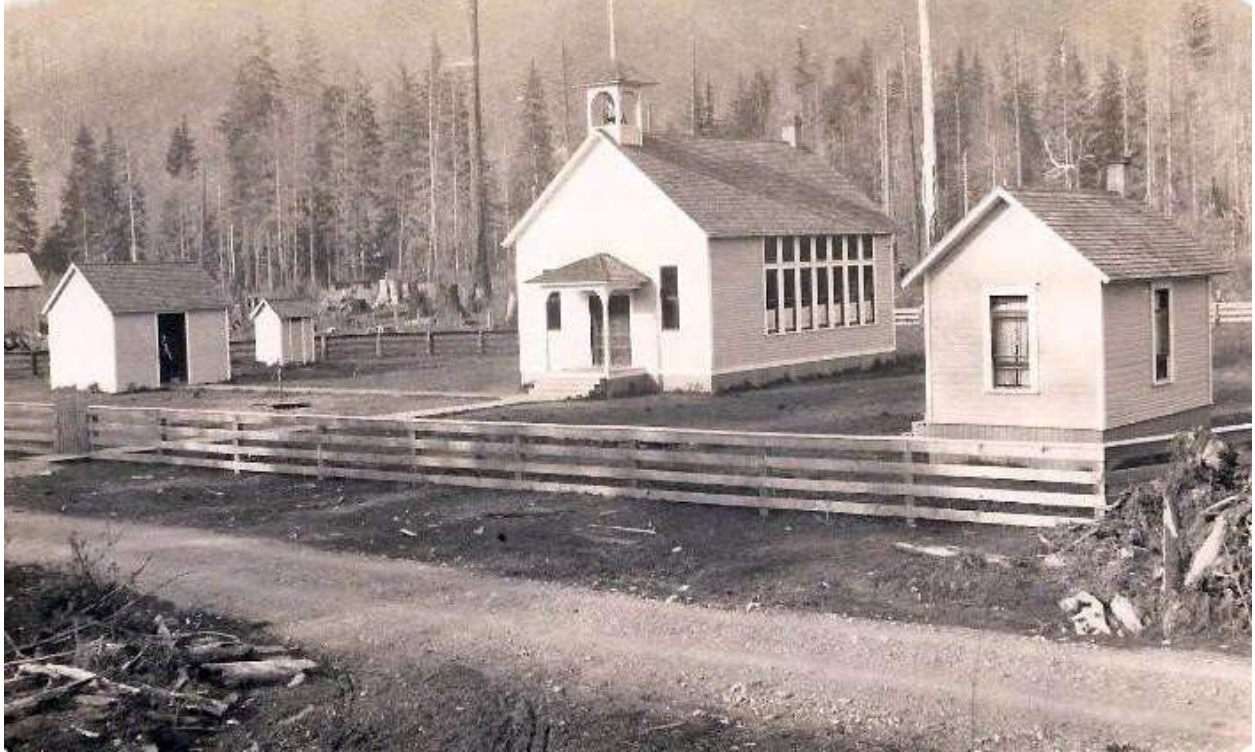
Location of outhouse and woodshed in relation to Riverside Community Club 2019.

An outhouse and woodshed are positioned approximately 60 feet slightly northeast of the rear of the school building. An outhouse was present at the school in 1912 as was a possible woodshed or storehouse. It is unknown if the current outhouse is the original 1912 outhouse or not. If the outhouse is the original, then the roofline has been changed from gable to shed style roof and a plastic skylight has been added. The existing outhouse is not in the 1912 location although outhouses were often moved to a different location when the hole was full. The open woodshed is crib style and is probably not 50 years old or older. The 1912 photograph of the Riverside School shows the original woodshed to have been an enclosed building with a side gable roof rather than the cribbed structure with a shed roof that is in place currently.

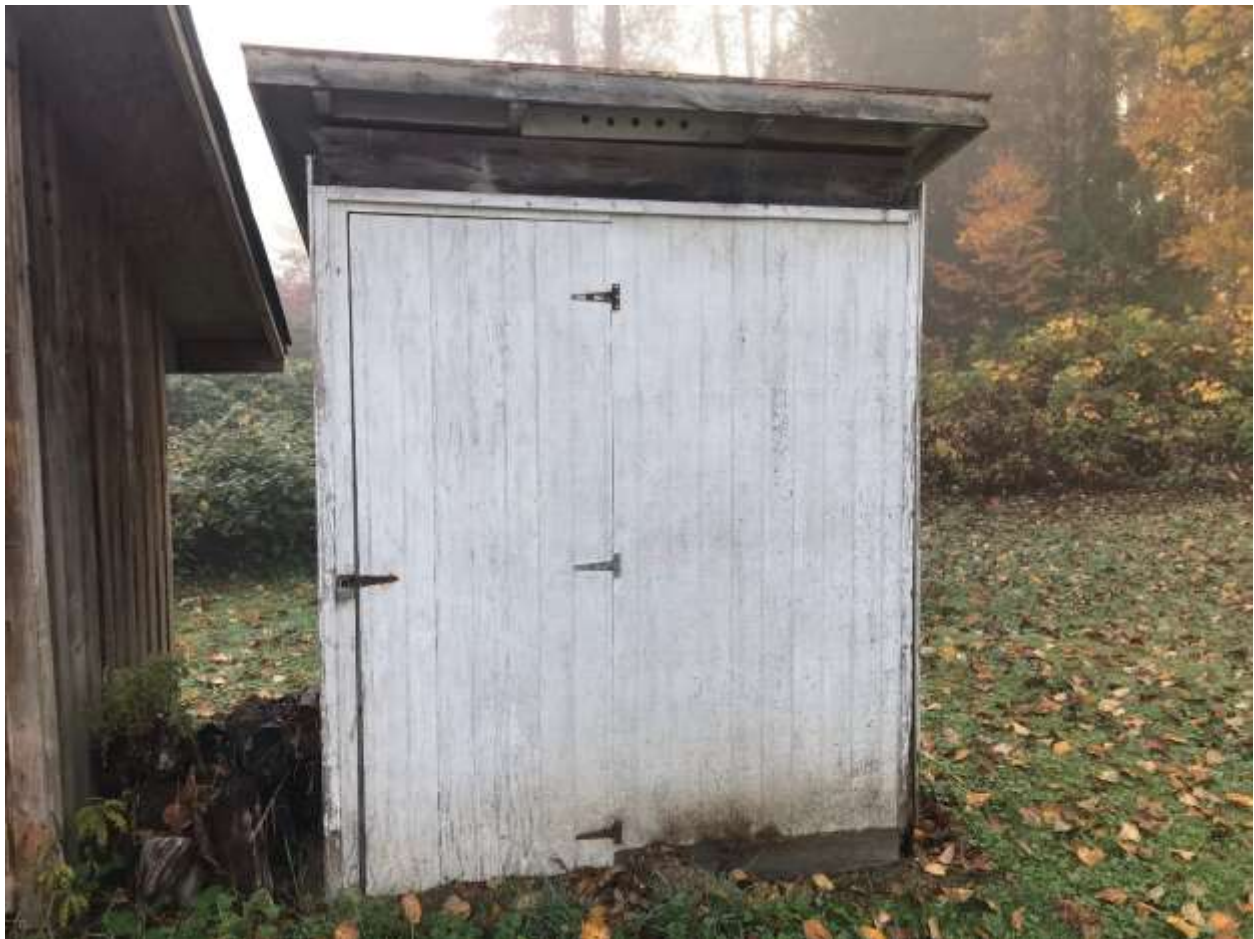
Location of original woodshed (left front), outhouse (left rear) and teacher's cottage (right) of Riverside School.

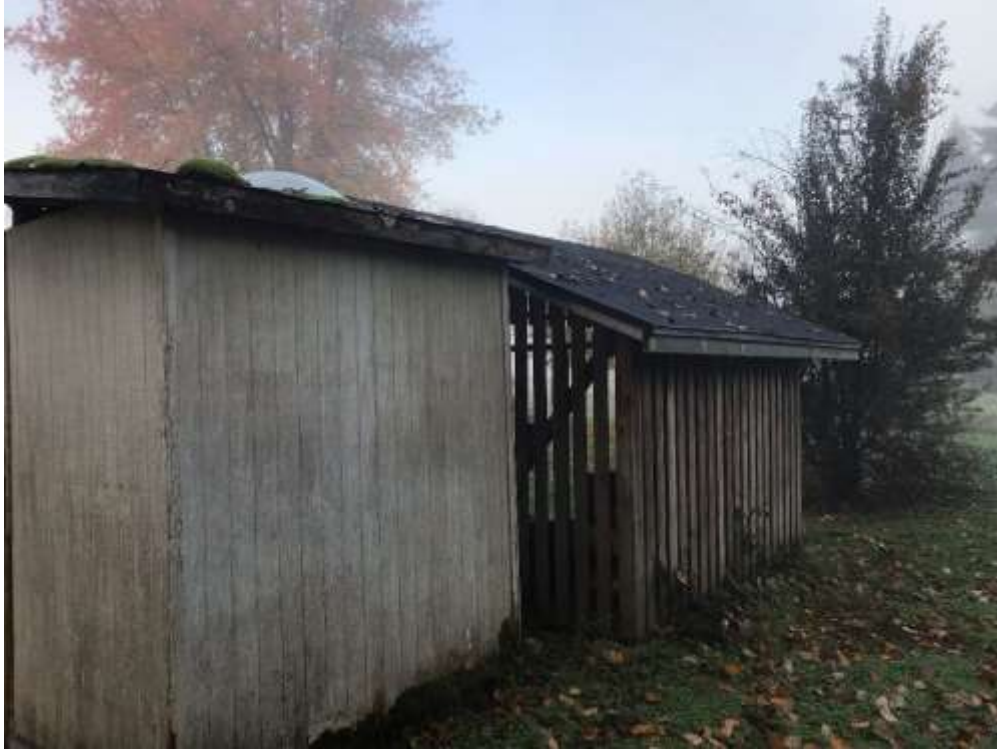
Front of outhouse 2019 (view east)

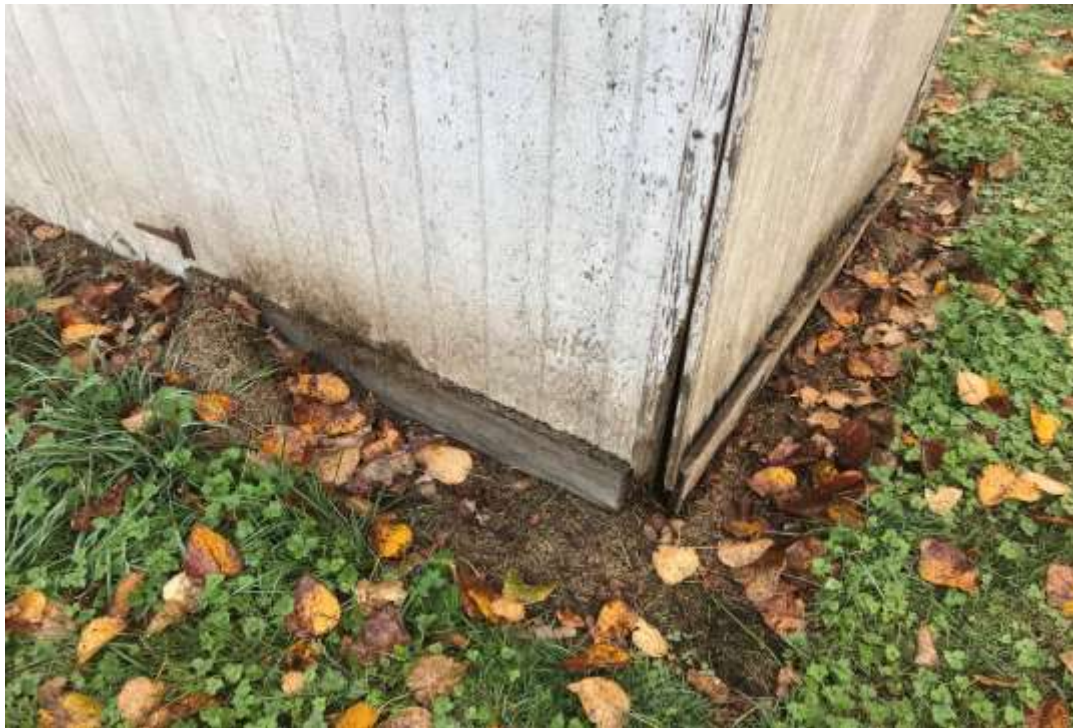
Back of outhouse and woodshed (view north)
